Annual Inspection

Winchester City Council

Meonwara PA (West Meon PC)

Meonwara Crescent, West Meon, Winchester,
Hampshire,

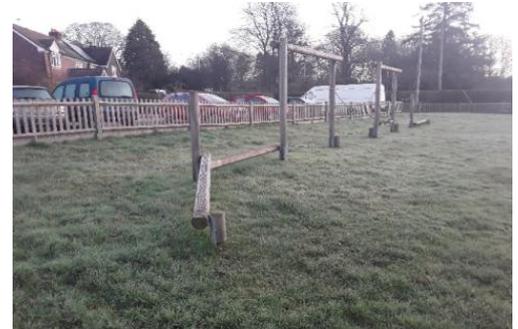
Item: Site General
Manufacturer: Owner/Operator
Surface Type: N/A
Equipment Compliance: N/A
Surface Area Compliance: N/A

BS EN 1176 recommends that signage, with information including the site address, contact information for maintenance issues and emergency contact details are provided on the playground - Provide in accordance with the recommendations set out in BS EN 1176 Part 7

The grass is overgrown within the play area and may hide hazards - Reduce the length of grass to an acceptable height and maintain

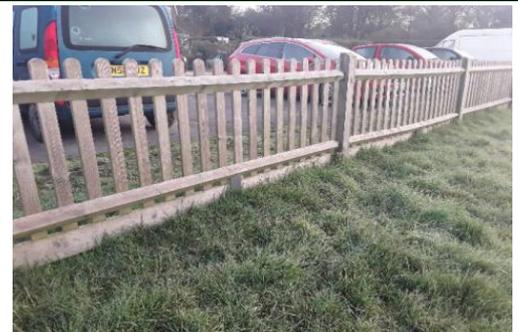
Item: Fencing - Timber
Manufacturer: Owner/Operator
Surface Type: Grass
Equipment Compliance: N/A
Surface Area Compliance: N/A

There is some strimmer / machinery damage apparent on the posts, this can penetrate the preservative applied to the timber and accelerate the rotting process - Monitor for any deterioration (rot) and replace as required

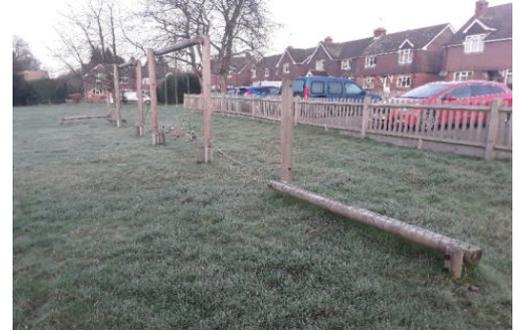
Item: Activity Trail
Manufacturer: Playdale Playgrounds Ltd
Surface Type: Grass
Equipment Compliance: No
Surface Area Compliance: Yes

The balance beam post is damaged - Monitor for any instability and remove any rough or sharp edges

The connecting links are in excess of 8.6mm and less than 12mm and fail the requirements of BS EN 1176 Part 1; clause 4.2.13, Chains - Monitor - No remedial work recommended

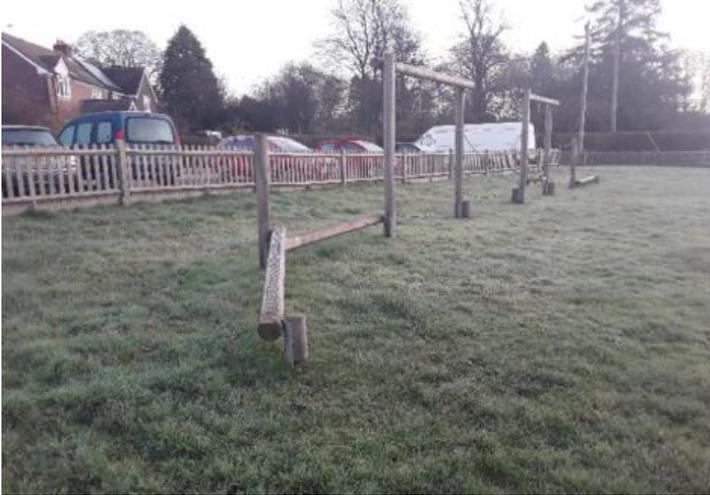
Item: Ancillary Items - Site General
Manufacturer: Owner/Operator

Finding: BS EN 1176 recommends that signage, with information including the site address, contact information for maintenance issues and emergency contact details are provided on the playground

Action: Provide in accordance with the recommendations set out in BS EN 1176 Part 7

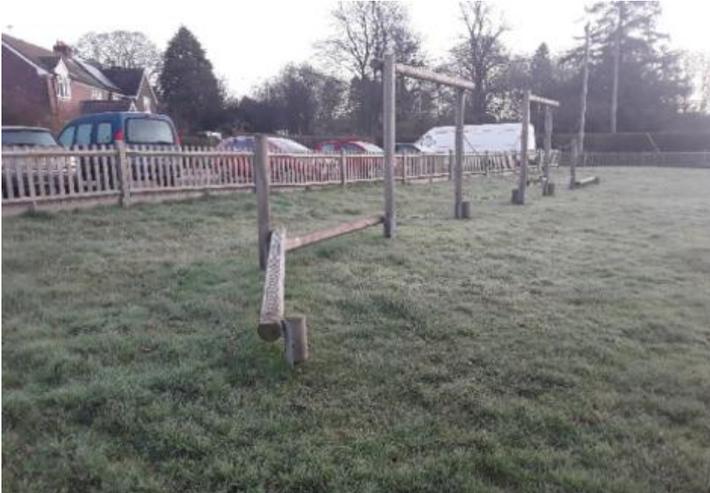
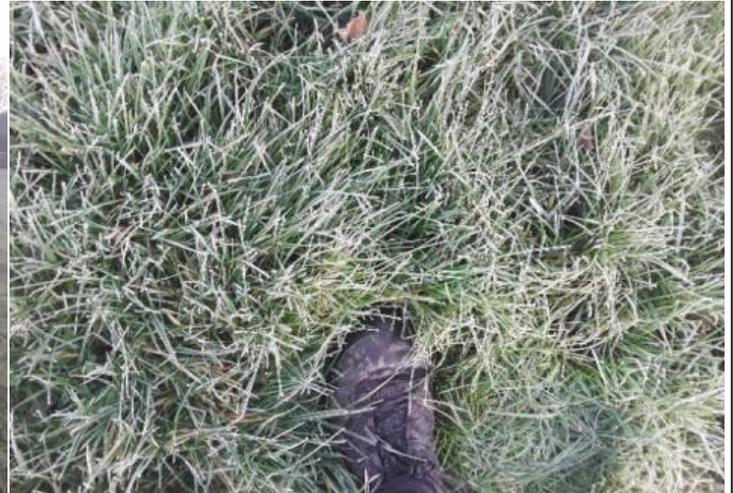
Item: Ancillary Items - Site General
Manufacturer: Owner/Operator

Finding: The grass is overgrown within the play area and may hide hazards

Action: Reduce the length of grass to an acceptable height and maintain

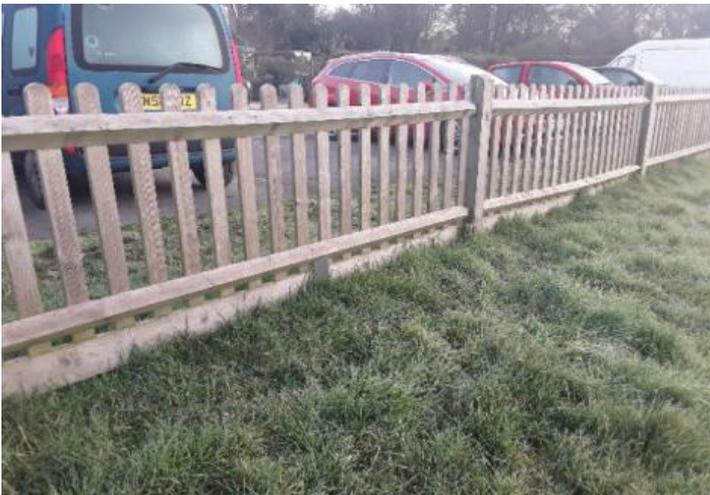
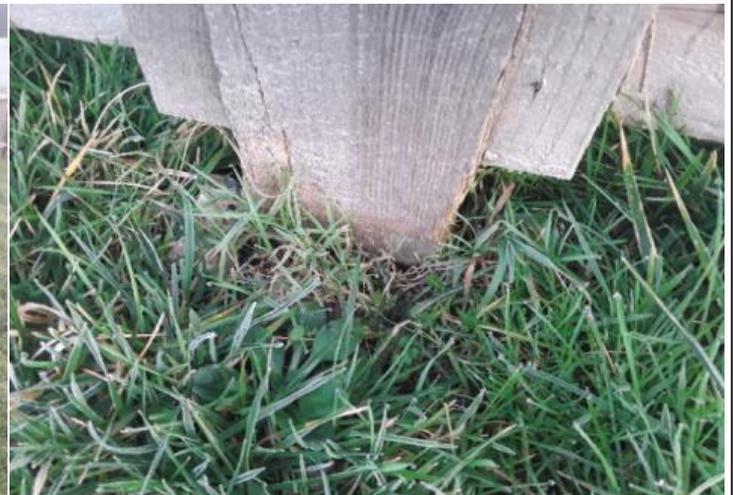
Item: Ancillary Items - Fencing - Timber
Manufacturer: Owner/Operator

Finding: There is some strimmer / machinery damage apparent on the posts, this can penetrate the preservative applied to the timber and accelerate the rotting process

Action: Monitor for any deterioration (rot) and replace as required

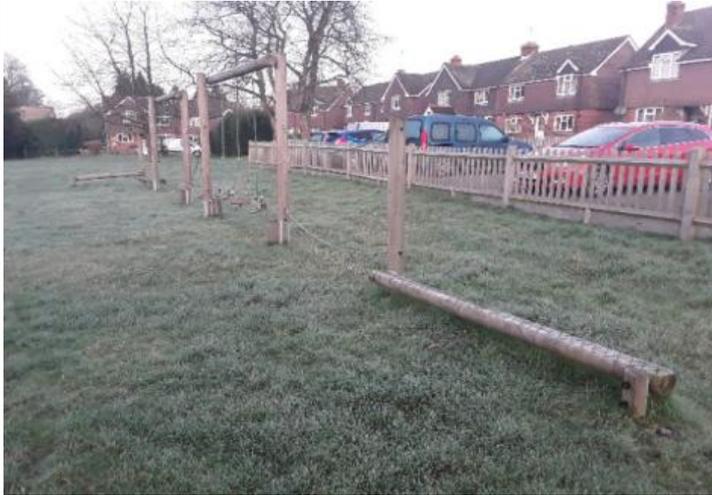
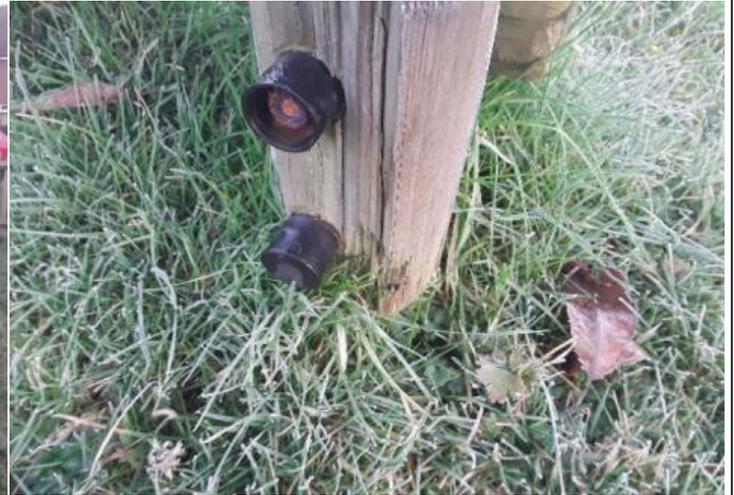
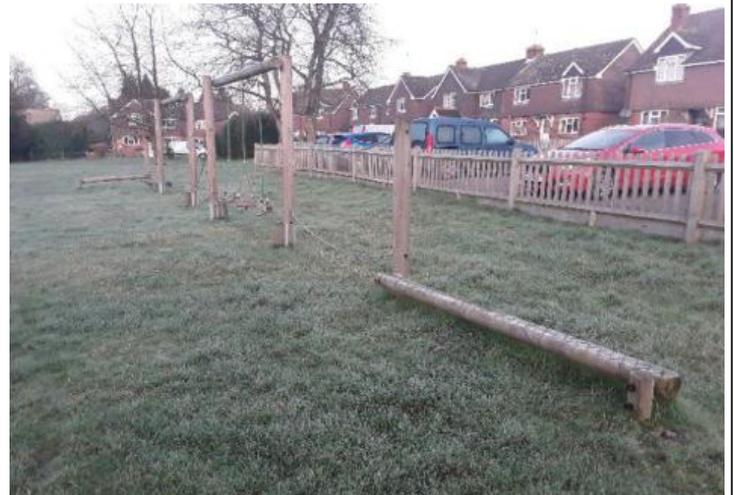
Item: Activity Equipment - Activity Trail
Manufacturer: Playdale Playgrounds Ltd

Finding: The balance beam post is damaged

Action: Monitor for any instability and remove any rough or sharp edges

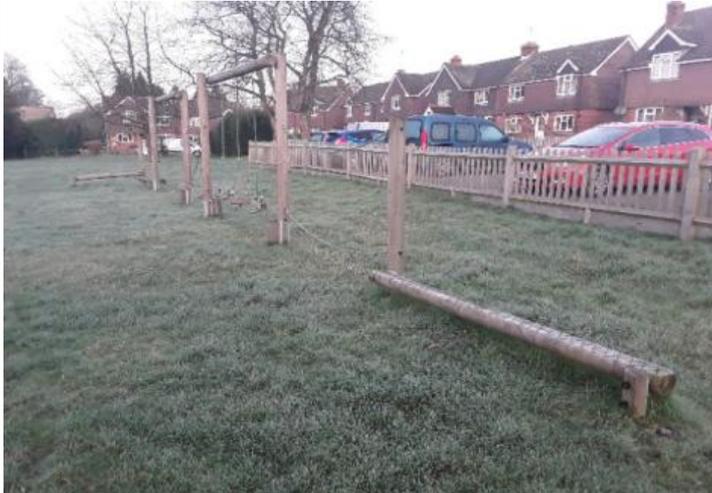
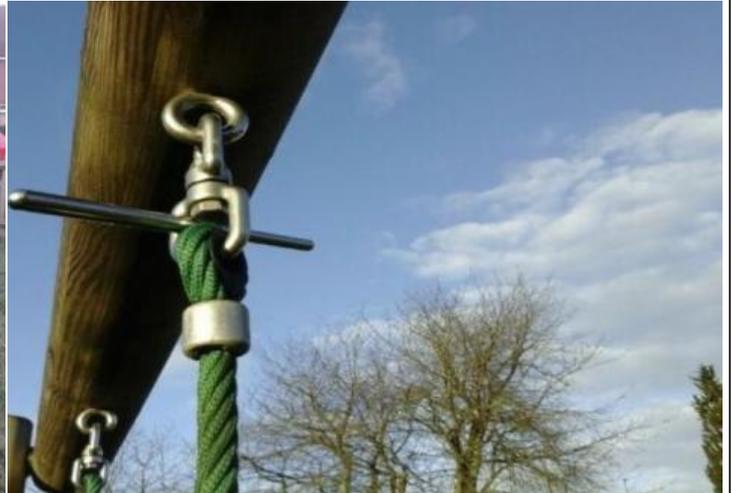
Item: Activity Equipment - Activity Trail
Manufacturer: Playdale Playgrounds Ltd

Finding: The connecting links are in excess of 8.6mm and less than 12mm and fail the requirements of BS EN 1176 Part 1; clause 4.2.13, Chains

Action: Monitor - No remedial work recommended
